Wartsila TM620 Diesel Engines

Solberg's Crankcase Ventilation System

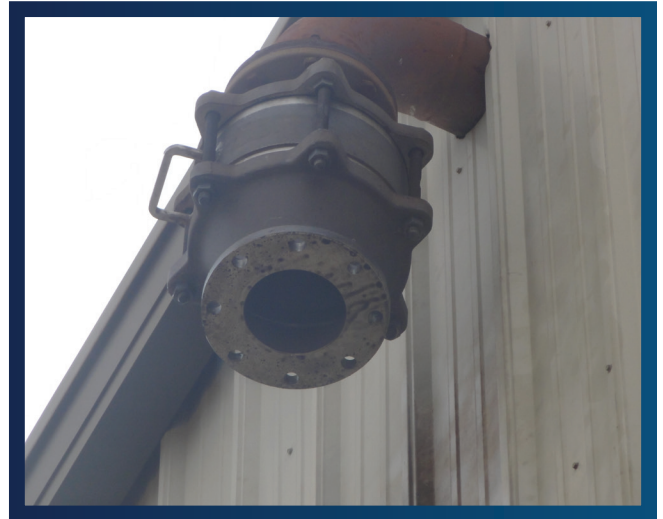
Emissions from Crankcase Vent

A power plant on the island of Kauai has an install base of 4 Wartsila TM620 diesel engines. Their previous crankcase filters were static and simply acted as a rough baffle for the oily vented crankcase emissions. The result was visible emissions into the atmosphere and condensing oil on the side of their building and on the ground. These engines ideally operate under slight positive pressure, and the operator asked Solberg to maintain this natural pressure while eliminating the visible emissions. Their retrofit project was spurred by the U.S. EPA RICE NESHAP emissions standards. RICE NESHAP requires the addition of a crankcase ventilation system for most diesel engines over 500HP.

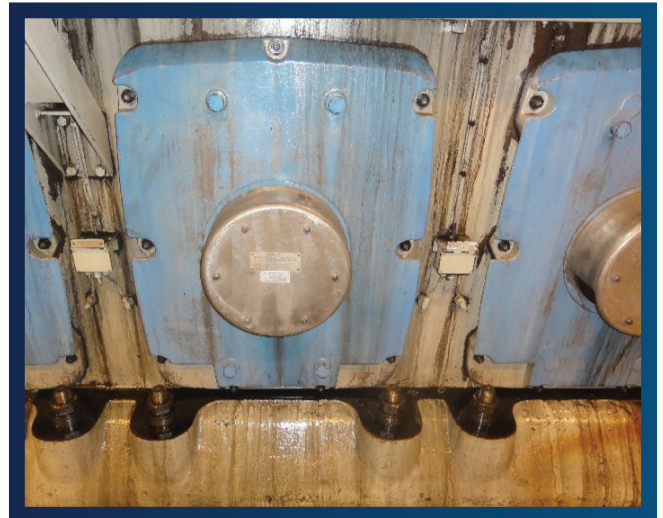
Evidence of Leaking Seals
